# INDOOR AIR QUALITY ASSESSMENT

Hull High School 180 Main Street Hull, Massachusetts

Prepared by: Massachusetts Department of Public Health Bureau of Environmental Health Assessment June, 2001 At the request of a parent, an indoor air assessment was done at the Hull High School (HHS) in Hull, Massachusetts. This assessment was conducted by the Massachusetts Department of Public Health (MDPH), Bureau of Environmental Health Assessment (BEHA). On March 28, 2001, a visit was made to this school by Cory Holmes, Environmental Analyst in the Emergency Response/Indoor Air Quality program, and Suzan Donahue, BEHA Research Assistant, to conduct an indoor air quality assessment.

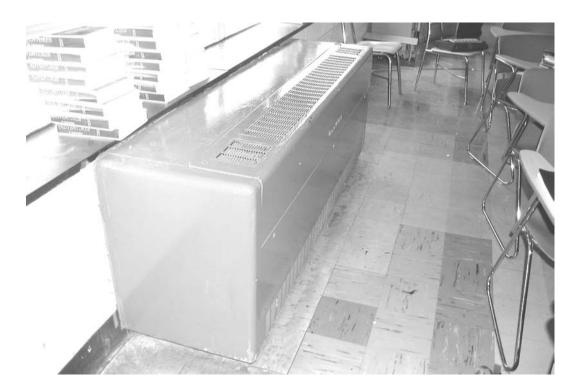
Fresh air in most classrooms is supplied by a unit ventilator (univent) system (see Picture 1). Univents draw air from outdoors through a fresh air intake located on the exterior walls of a building and return air through an air intake located at the base of each unit. The mixture of fresh and return air is drawn through a filter and a heating coil, and is then expelled from the univent by motorized fans through fresh air diffusers (see Figure 1). Univents were found turned off in classrooms throughout the school.

**Classroom Univent**

- 1. To maximize air exchange, the BEHA recommends that both supply and exhaust ventilation operate continuously during periods of school occupancy.
- 2. Examine each univent for function. Survey classrooms for univent function to ascertain if an adequate air supply exists for each room.
- Inspect exhaust motors and belts periodically for proper function, repair and replace as necessary.
- 4. Remove all blockages from univents and exhaust vents.
- 5. Once both the fresh air supply and the exhaust ventilation are functioning properly, an HVAC engineer should balance the system.

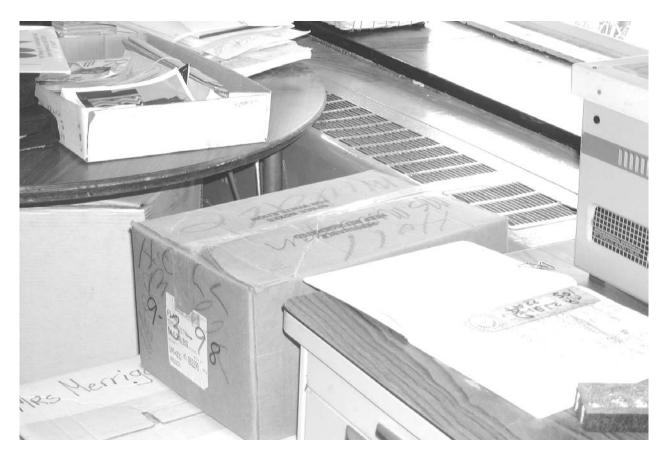
Obstructions to airflow, such as papers and books stored on univents and bookcases, carts and desks in front of univent returns were seen in a number of classrooms (see Picture 2). Some univents also contained accumulated dirt/debris. These univents should be cleaned before operating to prevent aerosolization of this material. In order for univents to provide fresh air as designed, intakes must remain free of obstructions. Importantly these units must remain "on" and allowed to operate while these rooms are occupied.

**Univent Obstructed by Materials**

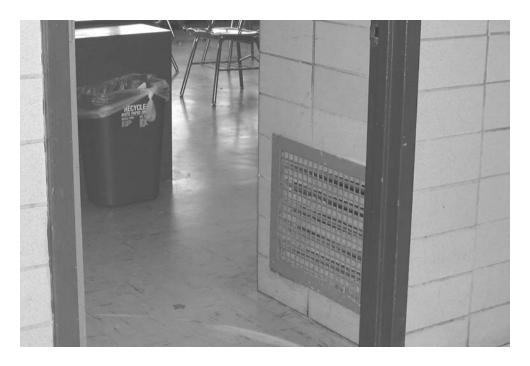
The mechanical exhaust ventilation system in the school consists of ducted, grated wall vents (see Picture 3). The location of exhaust vents can also limit exhaust

efficiency when the classroom hallway door is open. When a classroom door is open, exhaust vents will tend to draw air from both the hallway and the classroom. The open hallway door reduces the effectiveness of the exhaust vent to remove common environmental pollutants from classrooms. Without removal by the exhaust ventilation, normally occurring environmental pollutants can build up and lead to indoor air complaints. In addition, a number of exhaust vents were backdrafting cold air. Other vents were blocked by desks, chairs, boxes and file cabinets.

**Classroom Exhaust Vent Note Open Door**

To maximize air exchange, the BEHA recommends that both supply and exhaust ventilation operate continuously during periods of school occupancy. In order to have proper ventilation with a mechanical supply and exhaust system, the systems must be balanced to provide an adequate amount of fresh air to the interior of a room while removing stale air from the room. The date of the last balancing of these systems was not available at the time of the assessment. It is recommended that existing ventilation systems be re-balanced every five years to ensure adequate air systems function (SMACNA, 1994).

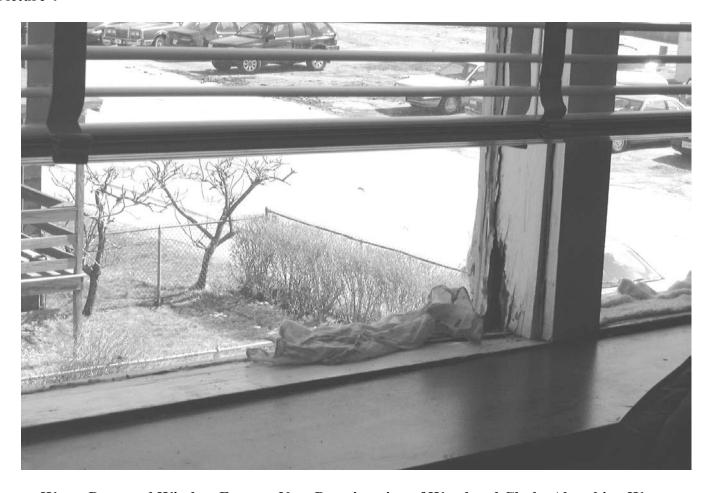
The school has well documented water penetration problems. In a large number of classroom water damage was seen on interior plaster, around windows and/or ceilings (see Pictures 4-6). The damage is most likely attributable to water penetration around window frames or through cracks in exterior wall bricks during rainstorms. As previously mentioned, window frames and panes are not watertight. Little, if any, caulking remains around windows. Cloth towels are used in a number of classrooms to absorb water leakage during rainstorms (see Picture 4). Towels used to soak up water around windows and other porous materials can serve as a mold growth medium; school officials reported that cloth towels are removed and laundered periodically to prevent microbial growth and associated odors. Numerous classrooms have water-damaged ceiling tiles from old roof leaks.

Water Damaged Window Frames, Note Deterioration of Wood and Cloths Absorbing Water

- 1. Water-damaged wood materials should be replaced (e.g., wood flooring, windowsills, etc.). These materials can be a source of microbial growth. Sources of water leaks (e.g., window frames, plumbing, roof, etc.) should be identified and repaired. Examine the non-porous surface beneath/around these materials and disinfect with an appropriate antimicrobial.
- 2. Repair/replace missing or damaged window caulking and broken windows building-wide to prevent water penetration through window frames.
- 3. Examine the feasibility of re-pointing exterior brickwork.
- 4. Consider providing a dedicated local exhaust to the chemical storage area.

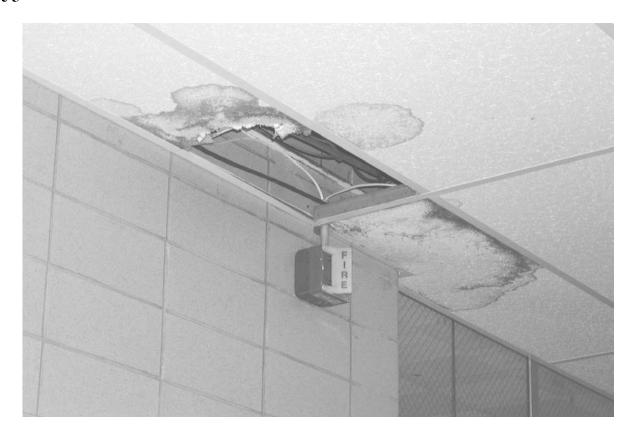
**Water Damaged Ceiling Tiles**

- 6. For buildings in New England, periods of low relative humidity during the winter are often unavoidable. Therefore, scrupulous cleaning practices should be adopted to minimize common indoor air contaminants whose irritant effects can be enhanced when the relative humidity is low. Drinking water during the day can help ease some symptoms associated with a dry environment (throat and sinus irritations).
- 7. Replace any remaining water-stained ceiling tiles and building materials.

Examine the area above and around these areas for microbial growth. Disinfect areas of water leaks with an appropriate antimicrobial.
- 8. Move plants away from univents in classrooms. Examine drip pans for mold growth and disinfect areas of water leaks with an appropriate antimicrobial where necessary.

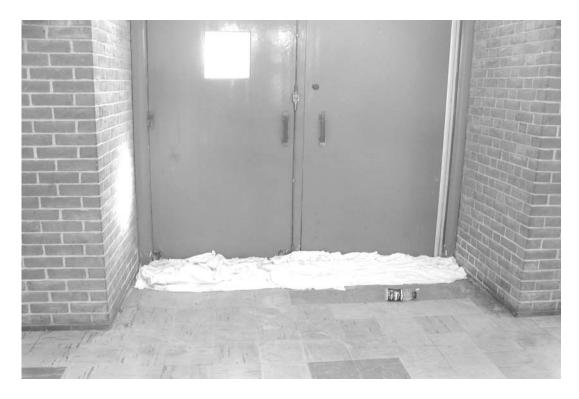
**Cloths Stationed in front of Exterior Door to Absorb Water**

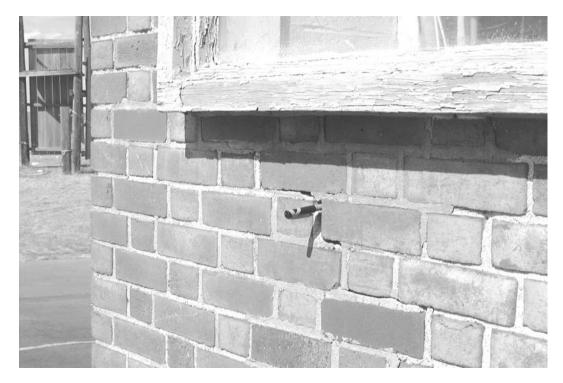
The exterior walls had spaces/cracks in brickwork. In many areas mortar around exterior brickwork appears to be crumbling or missing (see Pictures 7 & 8). These conditions are breaches of the building envelope and provide a means for water entry into the building. Repeated water penetration can result in the chronic wetting of building

materials and the potential for microbial growth. In addition large spaces may provide a means of egress for pests/rodents into the building.

Missing/Damaged Mortar in Exterior Brick (pen inserted into wall to provide scale for hole size)

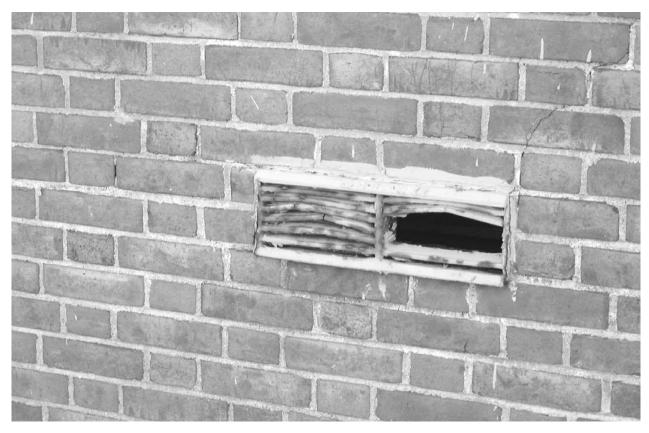
(Damaged Vent) Pathway for Pests/Rodents into Building

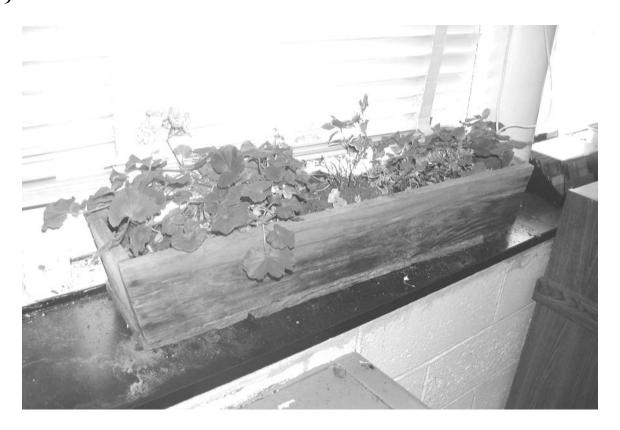
Several classrooms contained a number of plants. Plant soil and drip pans can be a source of mold growth. In several areas outdoor window boxes/planters were seen inside the building (see Picture 9). Window planters are designed for outdoor use and are not usually equipped with drip pans, which can result in water pooling and potential microbial growth. Plant soil and drip pans can be a source of microbial growth. Plants should also be located away from univents and exhaust ventilation to prevent aerosolization of dirt, pollen or mold.

Window Planter inside Building Note Water Damage as Evidenced by Dark Stains on Exterior of Window Box

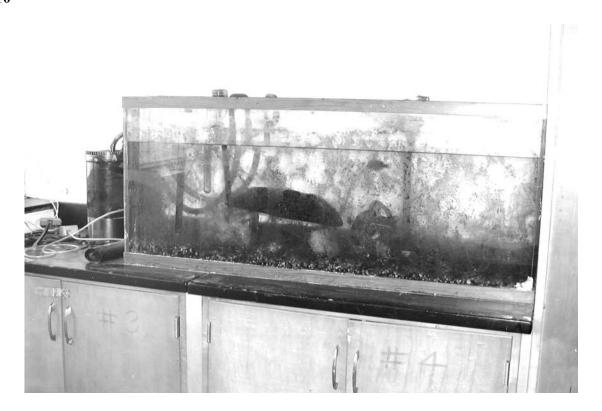
Room 114 contained a large fish tank containing standing water that was green with algal growth (see Picture 10). Aquariums should be properly maintained to prevent microbial/algal growth as they can emit unpleasant odors into the classroom.

**Aquarium with Algal Growth**

- 9. Clean and maintain aquariums and animal cages to prevent bacterial/mold growth and/or odors.
- 10. Replace missing ceiling tiles, to prevent the egress of dirt, dust and particulate matter into classrooms.
